Wrapping with Butyl Rubber Tapes—An Innovative Corrosion Protection for Bridge Cables

Reiner Saul, Dipl. Ing., Dr. Ing., E. h., Leonhardt, Andrä und Partner, Beratende Ingenieure VBI, GmbH, Stuttgart, Germany and **Oswald Nützel,** Dipl. Ing., Consulting Engineer, Munich, Germany. Contact: saul.reger@gmail.com DOI: 10.2749/101686612X13363869853013

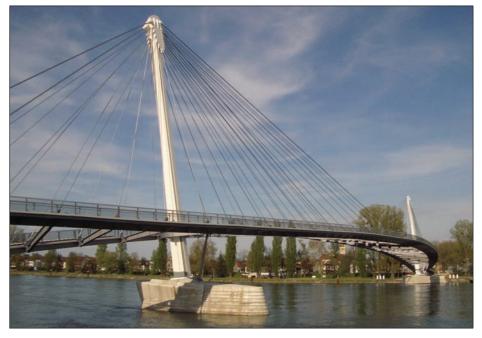
Fig. 1: Pedestrian and bicycle bridge Kehl–Strasbourg

The pedestrian and bicycle bridge across the Rhine between Kehl and Strasbourg with spans of 43,72 + 183,37 + 43,72 m = 270,81 m⁴ (*Fig. 1*) was an integral part of the 2004 German–French garden exhibition⁴.

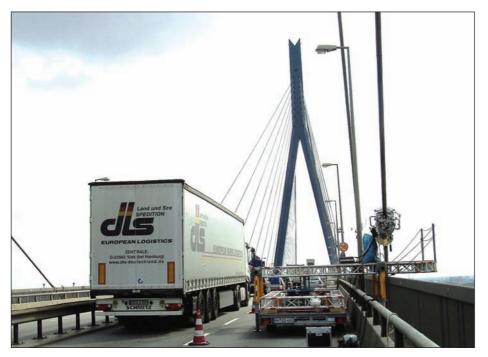
Fig. 8: Köhlbrand bridge at Hamburg, works under traffic

The bridge across the Köhlbrand, built from 1969 to 1974, is a cable-stayed bridge with spans of 97,5 + 325 + 97,5 m = 520 m. The steel-orthotropic bridge deck is 17,8 m wide, up to 58 m above the water, has a trapezoidal box girder and is supported by a total of 88 locked coil ropes with $\emptyset = 58$ to 118 mm (*Fig. 8*).¹¹

As the bridge across the Köhlbrand is a vital link to the Port of Hamburg (*Fig. 8*), complete closing of the bridge to traffic was out of the question.
